Verification of the HTS Cable at an Accident

– Protection Against the Ground Fault for 275 kV HTS Cable and Experiment –

*Tomohiro Takagi ^{*1}, Masashi Yagi ^{*2}*

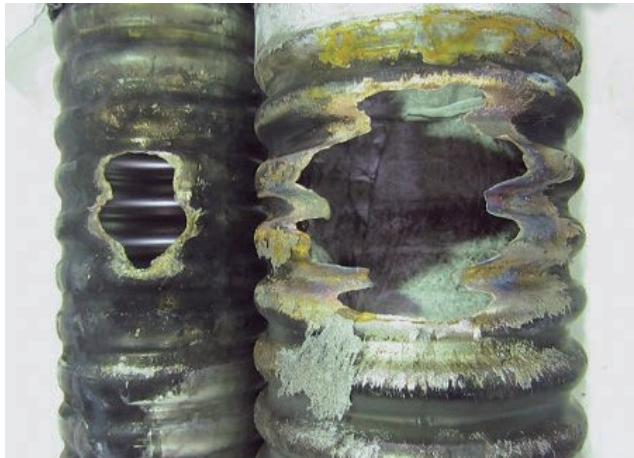
The sample was removed after the test and was dissected to check the damage condition. Figure 4 shows the damage appearance of the cryostat pipe of the sample energized at AC 10 kA. The left thinner pipe was the inner pipe and the right thick pipe was the outer pipe. The hole of the outer pipe was bigger than that of the inner. Some metal slugs around the hole on the outer pipe were seen, implying a part of the outer pipe melted and was scattered. The significant deformation was not observed in the remaining parts of both of cryostat pipes and it indi-

cated that the pipes were not exposed to the pressure to deform its shape. The heat of the arc discharge was the main cause of the pipes damage. Since the pipes had no damage except the ground fault point, the joule heat generation by the current flown in the cryostat pipes did not make damage to the pipes.

Figure 4 The Damaged appearance of the cryostat pipe with AC 10 kA.
The left is the inner pipe and the right is the outer pipe.

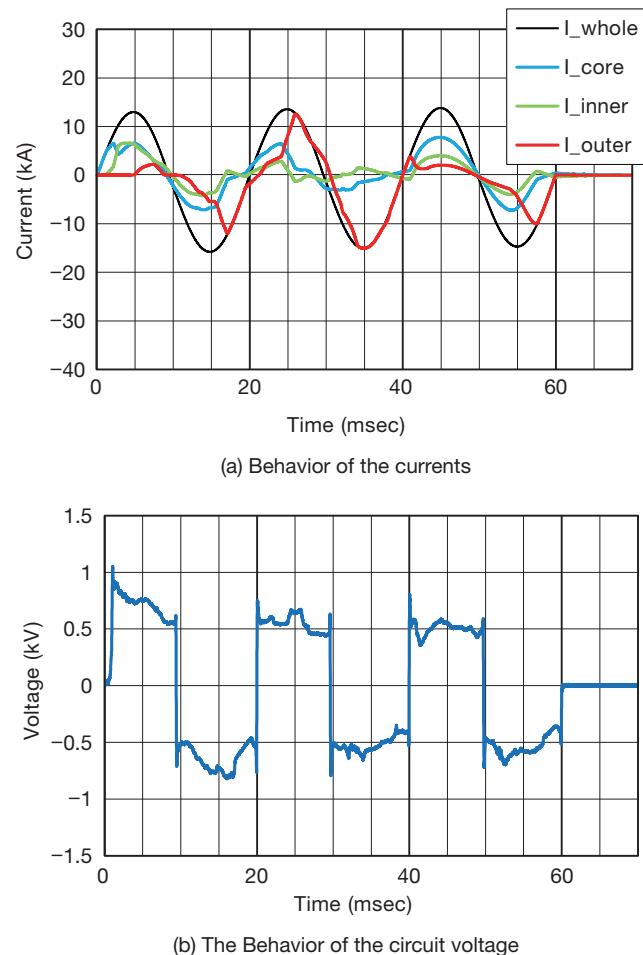
The behavior of the current of the sample at AC 10 kA is shown in Figure 5 (a). In the figure, the black line shows the current flowing up to the ground fault point (total current), the blue line shows the current flowing in the shield layer, the green line shows the current flowing in the inner cryostat pipe and the red line shows the current flowing in the outer cryostat pipe respectively. After the ground fault point, the current flowing in the three paths of the shield layer and both of the cryostat pipes. Since for another sample, when only less than 2 kA current flowed for 4 milliseconds in the outer cryostat pipe, the hole occurred in both of the cryostat pipes. According to these results, we presumed that when the current flowed in the outer cryostat pipe, that means when the arc reached the outer pipe, the cryostat pipe lost its integrity.

The behavior of the circuit voltage for the sample is shown in Figure 5 (b), in which the current of AC 10 kA flowed. The voltage relatively stabilized regardless of the current modulation, and showed a slightly high value before and after the polarity inversion.

No voltage was observed for 1 millisecond after the start of the current. This indicated that the current flowed in the iron pin that embedded in the core at the artificial ground fault point. After that time, the iron pin evaporated due to the joule heat, and the arc discharge had taken over the current. In the alternating current, the arc discharge paused on the polarity reversal. When the ionized plasma being in responsible for the arc discharge is lost by the electric charge recombination, it is impossible to make a re-ignition by the voltage application of around 10 kV, according to the previous paper⁸⁾.

Figure 5 The Behavior of the currents and the voltage for the sample at AC 10 kA.

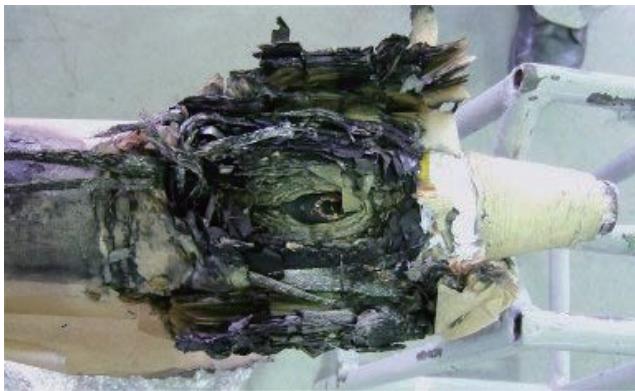
The two samples were examined with a current of AC 20 kA-3 cycles, and the samples were removed and taken down to be investigated. There were no damage on the appearance of the outer and inner cryostat pipe for both of type A and B, when examining the whole sample. Since the target of the examination is securing the integrity of the outer cryostat pipe, it showed that the protection system of both of type A and type B was effectively kept. On the other hand, the cable cores for both types were damaged, especially around the artificial ground fault point. The protection layer on the cable core of type A was damaged and appeared like a cleavage in the circumferential direction at the artificial ground fault point. The damage of the cable core of the type A is shown in Figure 7. As for the insulation layer, the conductor layer and the copper former located on the inner side of the protection layer, they had larger opened holes than the drilled hole at the artificial ground fault point. However the damages looked slight comparing with the outer protection layer. The damage of the cable core of the type B is the same as the type A.

Figure 7 The Damage appearance of the cable core of the type A.

of the insulating non-woven textile (the half-synthetic paper) on the cable core was shown in Figure 9, the behavior of the current indicated that the arc discharge broke the protection layer in 2 to 3 milliseconds after energizing. The damage appearance of the cable core shown in Figure 7 suggested that the protection layer was broken not by heat gradually but by an impact at once. Since the shield layer which was the destination of the arc discharge was located inside of the protection layer, in the case of the protection layer being reliable, the first arc discharge heated strongly the surrounding coolant. We presumed that the gasified coolant generated a large pressure and it broke the protection layer on the cable core as the role of a “lid” at once.

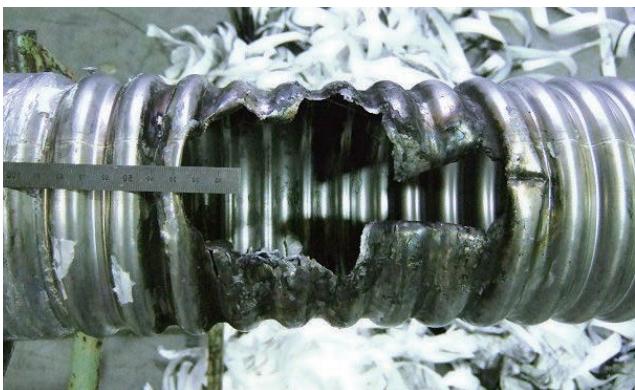
When all of the protection layers were removed from the inner cryostat pipe, there was a big hole formed on the corrugated pipe made of the SUS steel. The result was the same as the result of the simulated ground fault examination mentioned in the chapter 3. The periphery of the hole looked to be cut by the heat and the hole around area got no clear deformation. The shape and size of the hole on the corrugated pipe was consistent with the lost area of the protection layer. Figure 8 shows the appearance of the corrugated pipe damaged by the current test.

Figure 8 The Appearance of the damaged inner corrugated pipe.

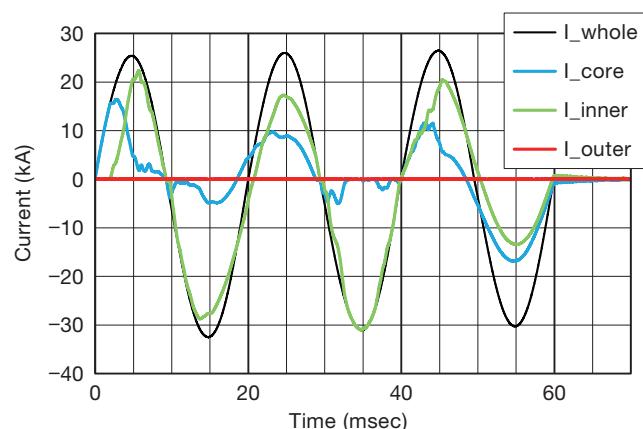
The behavior of the current flowed in the three paths, the shield layer and both of cryostat pipes, for the type A sample is shown in Figure 9. Comparing with the current behavior of the sample without the protection layer shown in Figure 5 (a), the clear difference was the current in the outer pipe indicated in the red line. The current in the outer pipe accounted for a substantial share of total current in Figure 5(a), however no current flowed in the outer pipe during the energizing period of 3 cycles in Figure 9. The behavior of the current in the outer pipe indicated that the relative huge arc discharge reached the outer pipe for the sample without the protection layer on the inner pipe shown in Figure 5 (a), on the other hand, the arc discharge did not reach the outer pipe for the sample (type A) with the protection layer on the inner pipe shown in Figure 9. The protection layer which consisted of the lamination of the insulating woven textile prevented the arc discharge from extending, that means the protection layer on the inner pipe protected the outer pipe from the ground fault current. The inside of the multi-layer close to the artificial ground fault point was lost or damaged by heat, however the outside of the layer was as-made. Since the protection layer consisted of the multi-layer of lots of non-woven textile and there were lots of the interface proportional to the numbers of the multi-layers, the heat conductivity in the stacking direction was decreased and the heat generated by the discharge did not transfer to the outside of the multi-layer.

The amount of the arc energy obtained from the product of the total current and the voltage was around 0.3 MJ for the sample without the protection layer when energized by 10 kA and 0.8 J for type A when energized by 20 kA. Since the average voltage of the latter case was a little bit higher than the former, the ratio of the released energy was higher than the current ratio of 1:2.

Figure 9 The Behavior of the currents for the type A sample.
