Completion of Submarine Cable Lines Combining Low Environmental Impact with Low Cost

1. 22-kV COMPOUND ARMORED SUBMARINE CABLE LINKING MIYAKOJIMA AND IRABUJIMA

2. 6.6-kV SUBMARINE CABLE LINKING NIJIMA AND SHIKINEJIMA

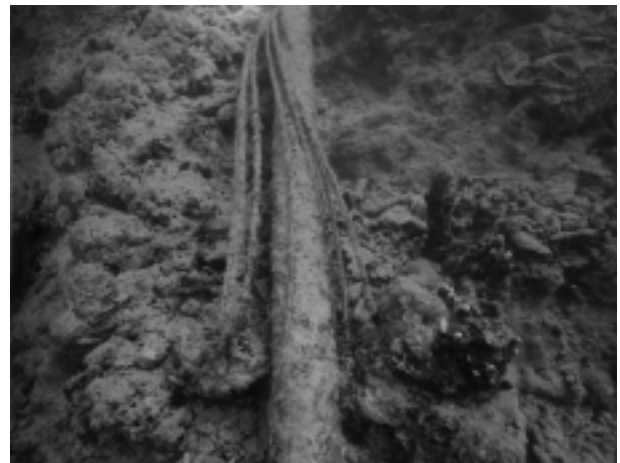
Photo 1 Submarine cable laid 28 years ago.

ventional submarine cables to the neighborhood of 20 years. Photo 1 shows the condition of a typical cable. This cable was laid 28 years ago, and there are places where the steel armor wire has frayed and parted so that on routes where the cable is lying on the seabed there is a chance that insulation faults could occur. And since the frayed ends of the steel armor wires are needle-sharp, published studies have long shown that the problem is not merely that of mechanical friction wear but of electrical corrosion.

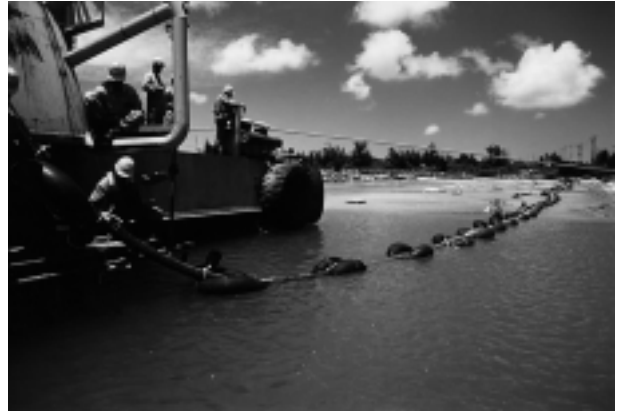
Photo 2 Cable landing on Miyakojima.

The cable laying process started from landing on the Miyakojima end, and then proceeded toward Irabujima. The landing point on the Miyakojima end was a pylon, and on the Irabujima end a cable house. Laying was carried out by an anchoring technique that made possible precise navigation of the cable-laying barge. In this method, as can be seen in Figure 4, an anchoring wire was first deployed and then taken up by a winch mounted on the cable-laying barge, moving it forward and enabling the cable to be laid precisely along the pre-determined route.
