# Development of Cold-Shrinkable Terminations for 6600-V XLPE Cable

**ABSTRACT** Slip-on terminations used heretofore on 6600-V XLPE cables come in two types depending on the level of pollution in the area where they are to be used--the pothead type for areas of heavy pollution and the outdoor type for ordinary areas. Pothead terminations have the disadvantages of being heavy and difficult to handle and when EP rubber out-door-type terminations were incorrectly substituted in areas of heavy pollution, instances of insulation breakdown occurred. And since both are of the slip-on type, incidents of breakdown have also occurred, though infrequently, due to insufficient insertion of the cable. Against this background the authors have developed a new type of termination made of silicone rubber for 6600-V XLPE cables which is easy to assemble, guards against problems of improper installation on the cable, and can be used in both ordinary and heavily polluted areas.

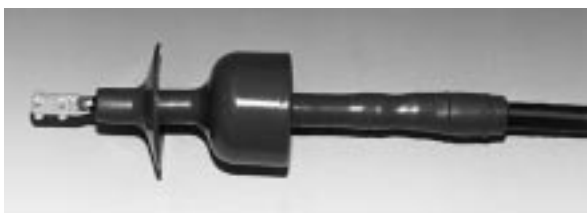
Photo 1 Newly-developed cold-shrinkable termination

ordinary and heavily polluted areas, so all performance specifications were set with reference to the current pothead type. With respect to installation operations, the objective was to improve procedures requiring a high degree of skill, and to suppress installation errors due to insufficient cable insertion. Photo 1 shows the new termination developed to satisfy these target specifications.

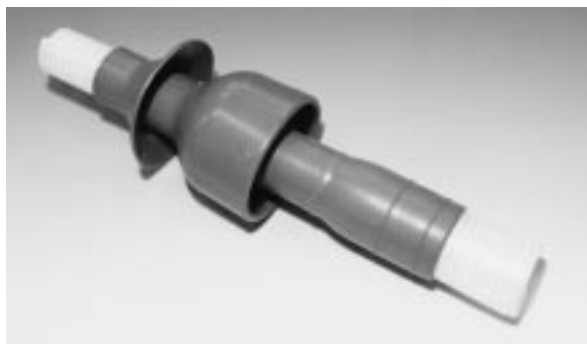
Photo 2 Expanded state

The installation method adopted was cold shrinkable type utilizing the inherent elasticity of rubber, in which the cable is attached by keeping the inner diameter of the termina-

tion several times larger than the outer diameter of the cable and then releasing it at the designated point of attachment (Photo 2). This method made it possible to eliminate the insertion force of the slip-on termination to the cable.

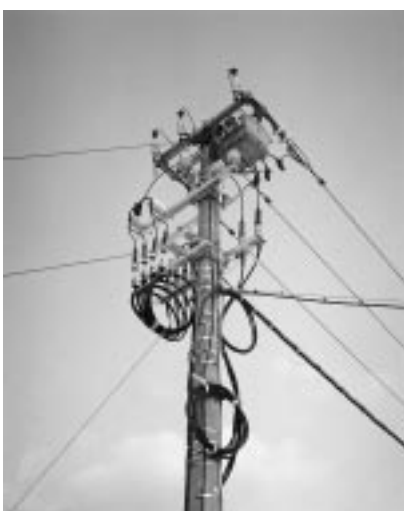
Photo 4 Outdoor exposure test (heavy pollution area)

The sites selected for the tests were: an area located on the sea about 10 m distant from the water and subject to heavy pollution from sea water and salt-laden winds; an area of medium pollution where conditions were extremely severe owing to the presence of diesel train exhaust, dust and iron powder from brakes, without the cleansing effect of rain; and an area of light pollution located in a railway station parking lot subject to the effects of exhaust gases, dust and dirt. The three sites are pictured in Photos 4 through 6. Four samples were exposed at each site, and at regular intervals one was removed for evaluation.

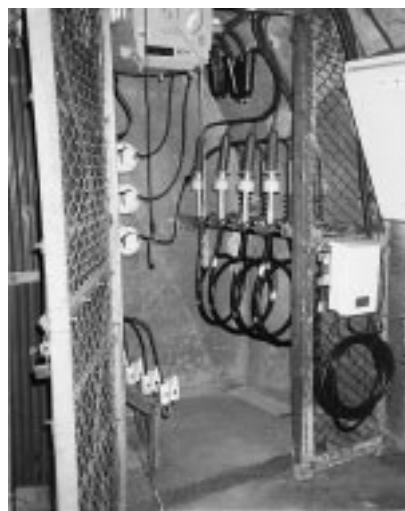
Photo 5 Outdoor exposure test (medium pollution area)

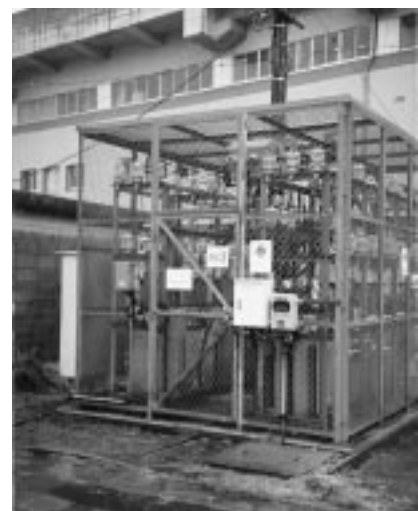
Photo 6 Outdoor exposure test (light pollution area)

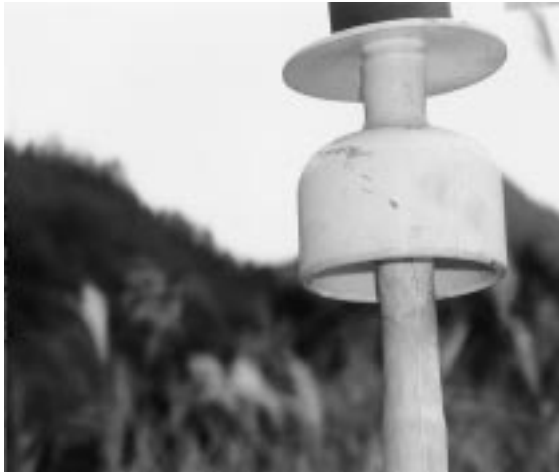
**Photo 7** Sample after exposure for 1 year in area of medium pollution

Photo 7 shows a sample which was removed after one year's exposure at the area of medium pollution. No abnormalities due to erosion or tracking were found. The other

samples were also found to be free of observable abnormalities during the course of the exposure tests, irrespective of the environment in which they were placed.

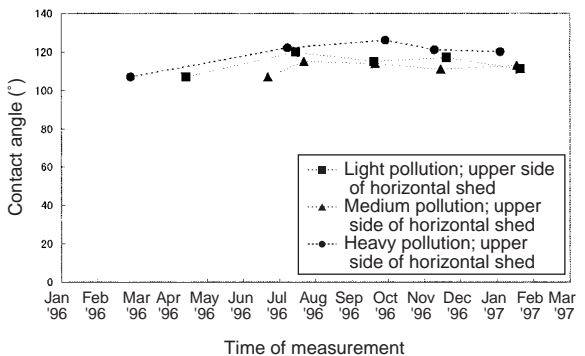
**Figure 7** Changes in contact angle to sample surface at each test site

When removed, the samples were also examined for changes in the contact angle as a sign of change in hydrophobicity. Figure 7 shows the results. There was no major change in contact angle, irrespective of the environment, suggesting that the hydrophobicity of the surface of terminations made of silicone rubber was retained throughout the test period.
