Development of Composite Insulators for Overhead Lines (Part 2)

by Satoshi Kobayashi* , Yutaka Matsuzaki* , Yoshihiro Arashitani*² and Ryuzo Kimata*

ABSTRACT Furukawa Electric's composite insulators are characterized by a hermetically sealed structure made by integral molding with a silicone rubber sheath that covers up to the end fittings. Exposure tests on full-size insulators were carried out in Okinawa at 77 kV over a 5-year period to evaluate them under the usage conditions prevailing in Japan. No deterioration was observed, nor was any deterioration observed in accelerated aging tests carried out on full-size insulators in accordance with IEC 61109 Annex C, demonstrating ample reliability. Service life of the composite insulators was estimated by charged exposure tests and accelerated aging tests with leakage current as the parameter. A figure of not less than 34 years was arrived at as the period within which slight deterioration would occur under the severe sea-salt contamination occurring in Okinawa, thereby confirming a sufficiently long period of resistance.

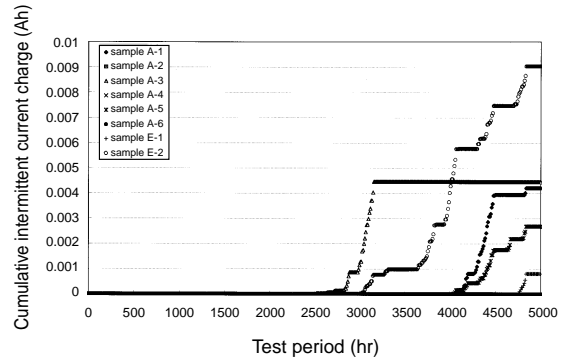
Figure 5 Transition of intermittent current.
